Proposed Mixed Use Development

Road Safety Audit Stage 1/2

**SEPTEMBER 2021**

<b>Client</b>	Bellmount Developments
<b>Project Title</b>	Proposed Mixed Use Development
<b>Project Location</b>	Blackpool, Cork City
<b>Document Title</b>	Road Safety Audit Stage 1/2
<b>Document No.</b>	MHL-20068TT-RED-DOC03-RSA
<b>Job No.</b>	20068TT

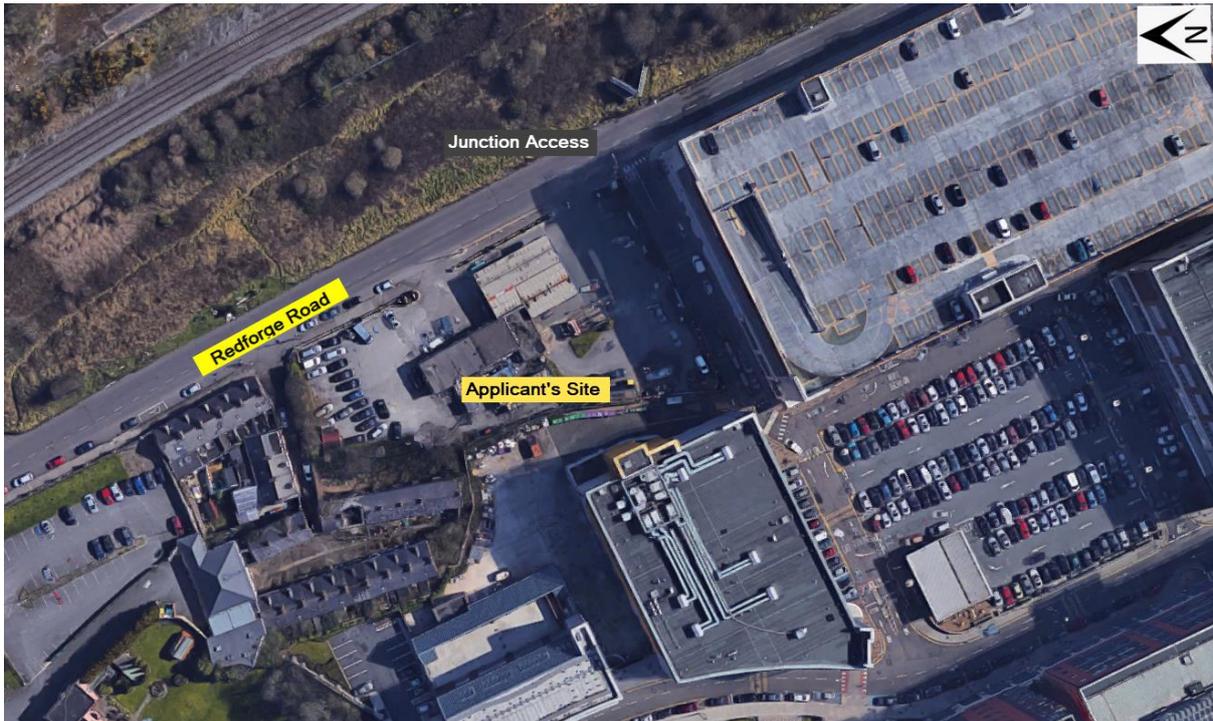
Figure 5.1 Existing Applicant's site on Redforge Road

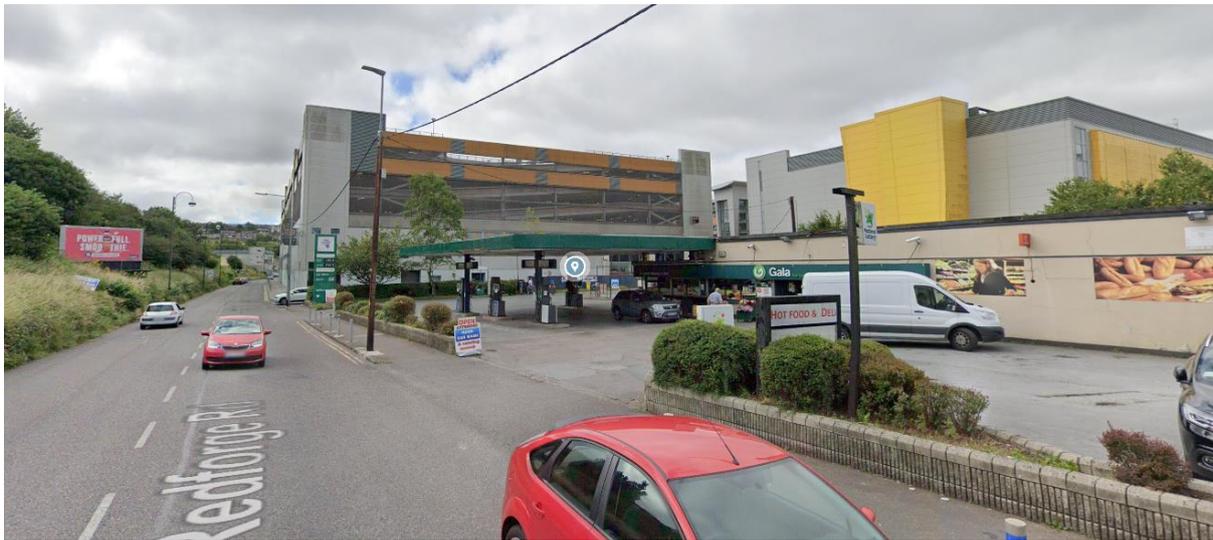
Figure 5.2 Existing site access with Redforge Road

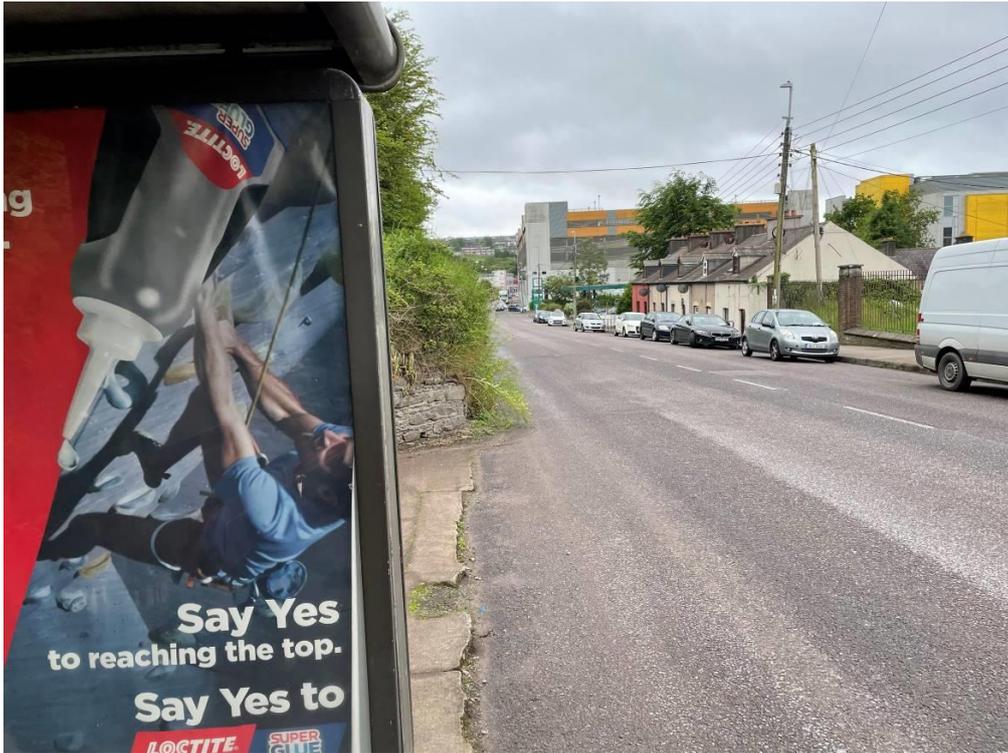
The existing bus stop kerbing at the farside bus stop to the north of the applicant's site has deteriorated over time due to improper kerbing installed at this location. This broken kerbing is a major trip hazard which could lead to pedestrian injury by loosing their footing or tripping into oncoming traffic.

Figure 5.3 Existing farside bus stop, looking south

Ensure that the bus stop kerbing is replaced along the length of the bus stop with appropriate heavy duty Kassel Bus Stop kerbing.

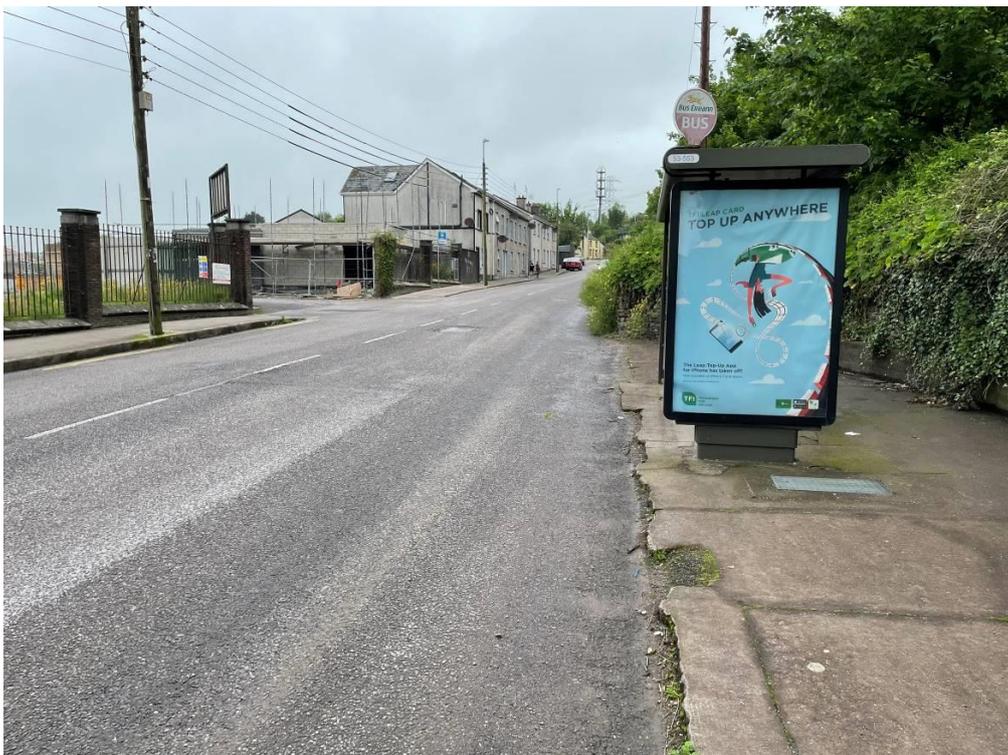
Figure 5.4 Existing farside bus stop, looking north

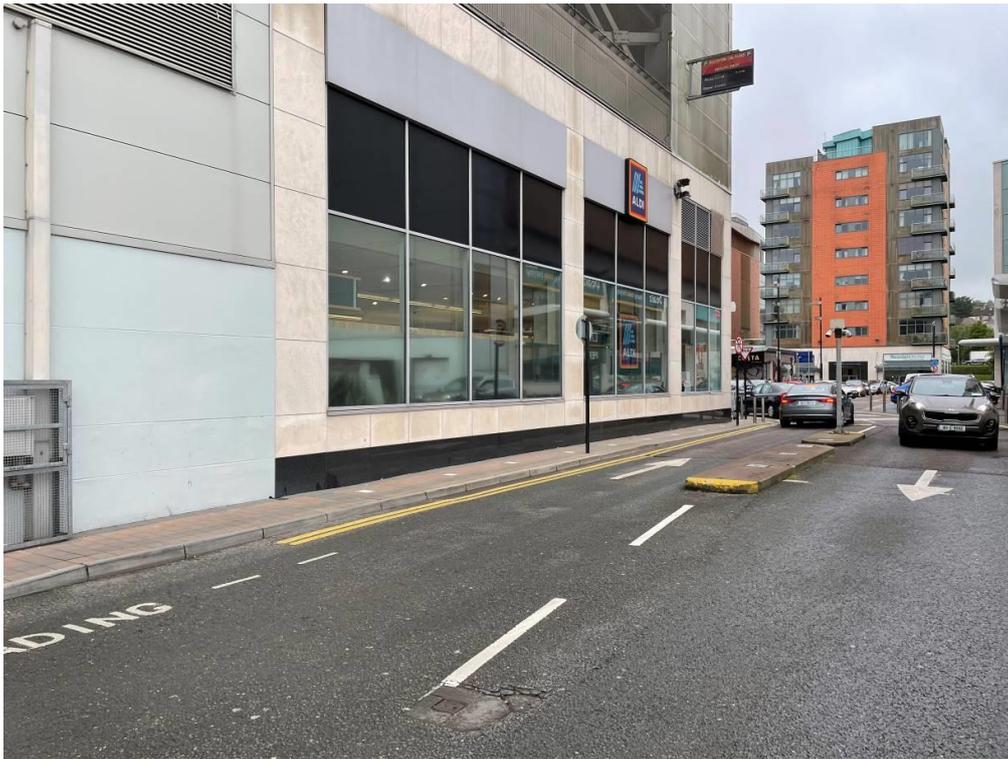
**Figure 5.5 Existing Retail Park Laneway**

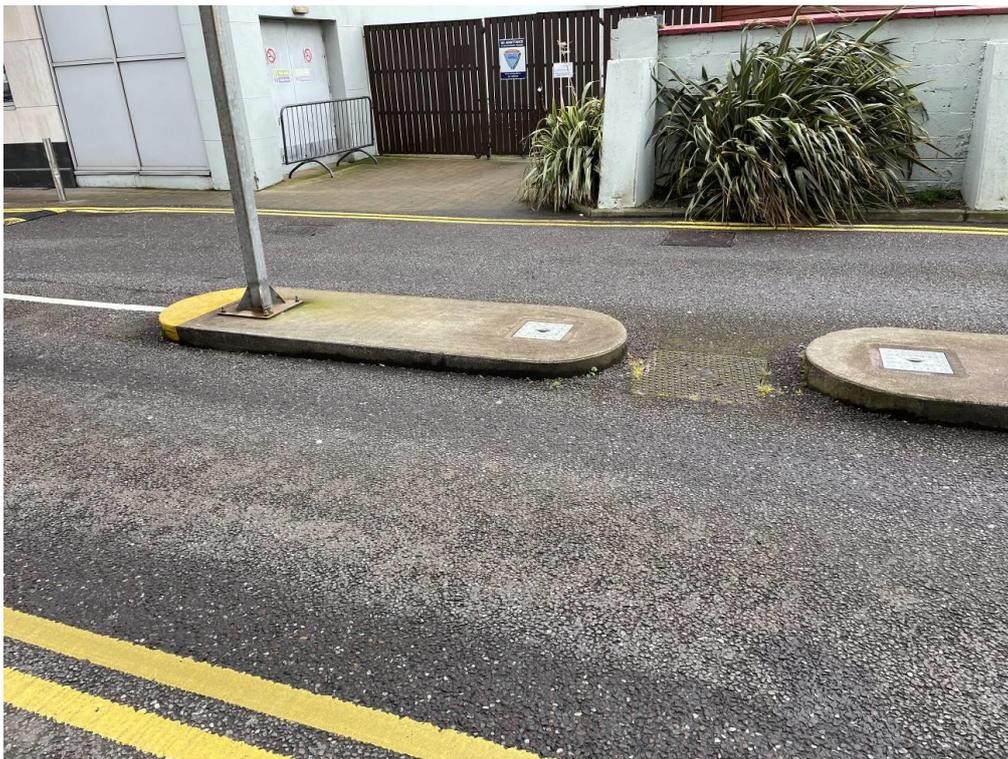
**Figure 5.6 Existing side entrance to applicant's site from the Retail Park Laneway**
