Proposed Mixed Use Development

Quality Audit Report

**SEPTEMBER 2021**

<b>Client</b>	Bellmount Developments
<b>Project Title</b>	Proposed Mixed Use Development
<b>Project Location</b>	Blackpool, Cork City
<b>Document Title</b>	Quality Audit Report
<b>Document No.</b>	MHL-20068TT-RED-DOC04-QAR
<b>Job No.</b>	20068TT

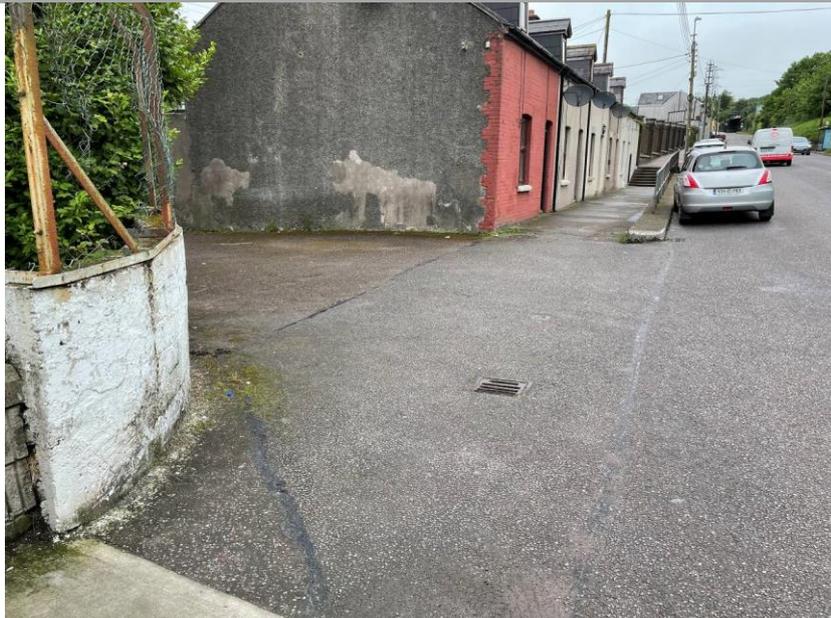
### 6.1.1 QAR Problem Route 1 Ref No.1

**Figure 6.1 Photo Direction A**

**Issue:** The wide entrance between the applicant's site boundary and nearby cottages, is a discontinuity in the pedestrian facilities at this location. The pedestrian priority is not evident with no appropriate signage present. The footpath is at grade with the nearby carriageway, such that vulnerable road users are at higher risk from collision potentially due to the lack of vehicle separation.

**Recommendation:** Provide appropriate signage, uncontrolled tactile paving/dropped kerbing and pedestrian crossing facilities at this location to ensure continuity of the footpath network.

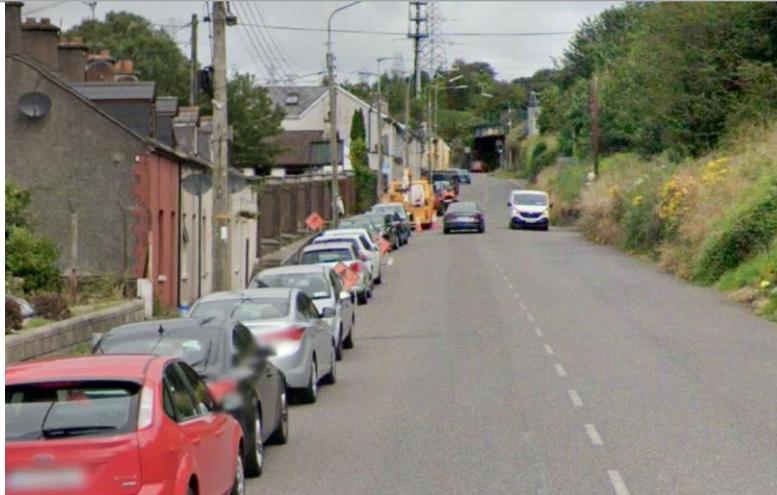
### 6.1.2 QAR Problem Route 1 Ref No.2

Figure 6.2 Photo Direction A

**Issue:** The carriageway between the applicant's site boundary and nearby bus stops along Redforge Road is very wide, leading to ambient traffic speeds higher than what is appropriate for the residential area.

**Recommendation:** Provide appropriate signage, raised tables, narrowed carriageway in line with DMURs requirements.

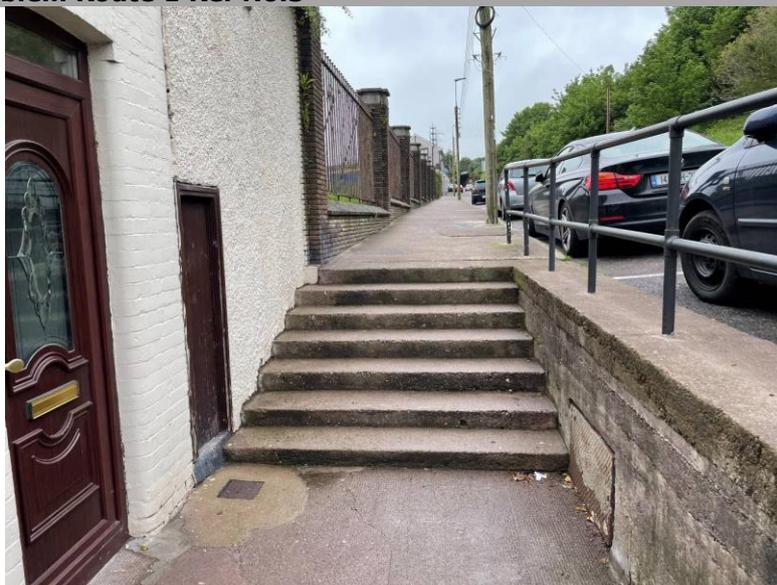
### 6.1.3 QAR Problem Route 1 Ref No.3

Figure 6.3 Photo Direction B

**Issue:** Pedestrian connectivity to the north is provided by public steps. These steps have been installed to account for the inclined gradient of the nearby Redforge Road. This is an issue for mobility impaired users.

**Recommendation:** Appropriate ramp facilities and tactile paving (top and bottom of steps) to be employed to allow for disabled connectivity access to the bus stops located north of this location. If these ramp facilities cannot be delivered at this location, appropriate tactile paving and accessible hand rail should be provided.

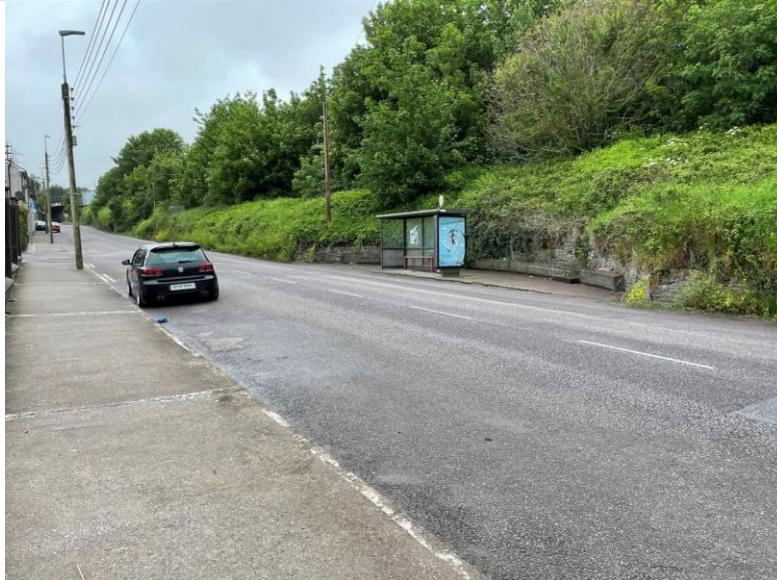
#### 6.1.4 QAR Problem Route 1 Ref No.4

Figure 6.4 Photo Direction C

**Issue:** Pedestrian connectivity to the far side bus stop is not present. Unregulated pedestrian crossings could lead to collision, injury with passing traffic.

**Recommendation:** Appropriate pedestrian crossing facilities to be provided at this location, linking the far side bus stop to the existing public footpath network.

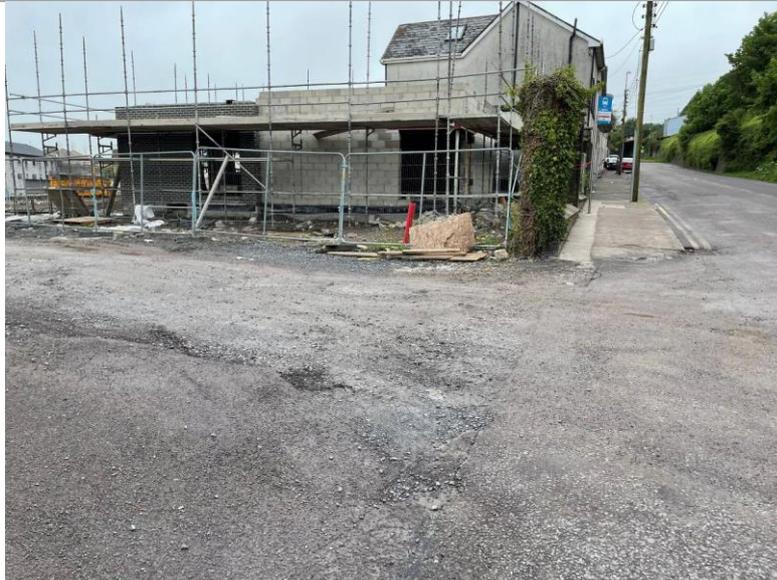
#### 6.1.5 QAR Problem Route 1 Ref No.5

Figure 6.5 Photo Direction D

**Issue:** The wide entrance just south of the nearside bus stop is in poor condition and is a discontinuity in the pedestrian facilities at this location. The pedestrian priority is not evident with no appropriate signage present. The footpath is at grade with the nearby carriageway, such that vulnerable road users are at higher risk from collision potentially due to the lack of vehicle separation.

**Recommendation:** Provide appropriate signage, uncontrolled tactile paving/dropped kerbing and pedestrian crossing facilities at this location to ensure continuity of the footpath network. Review the intended improvements at the junction related to the adjoining development which may address this issue.

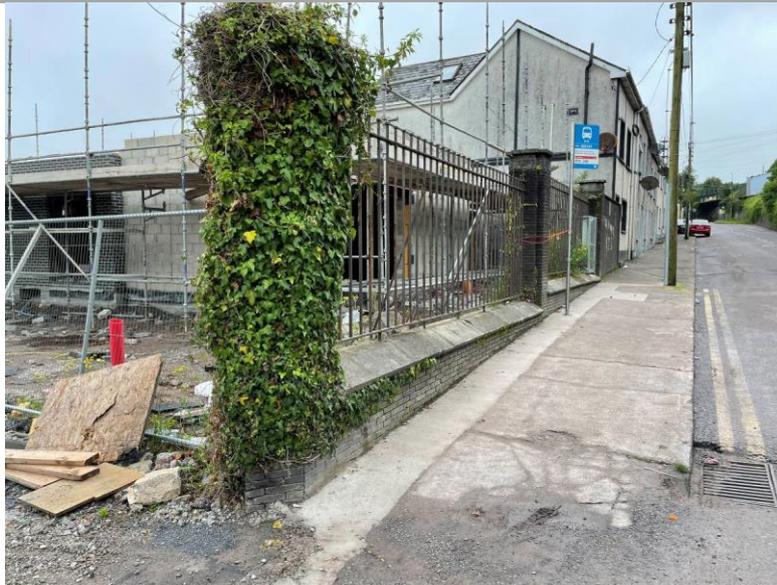
**6.1.6 QAR Problem Route 1 Ref No.6**

**Figure 6.6 Photo Direction E**

**Issue:** The existing bus stop does not provide a shelter for commuters. The existing footpath is broken, in a state of deterioration.

**Recommendation:** The possibility of providing appropriate bus stop shelter to be evaluated at this location and provided if feasible. The existing footpath should be reinstated to avoid/ minimise potential trip hazards to users. Review the intended improvements at the junction related to the adjoining development which may address this issue.

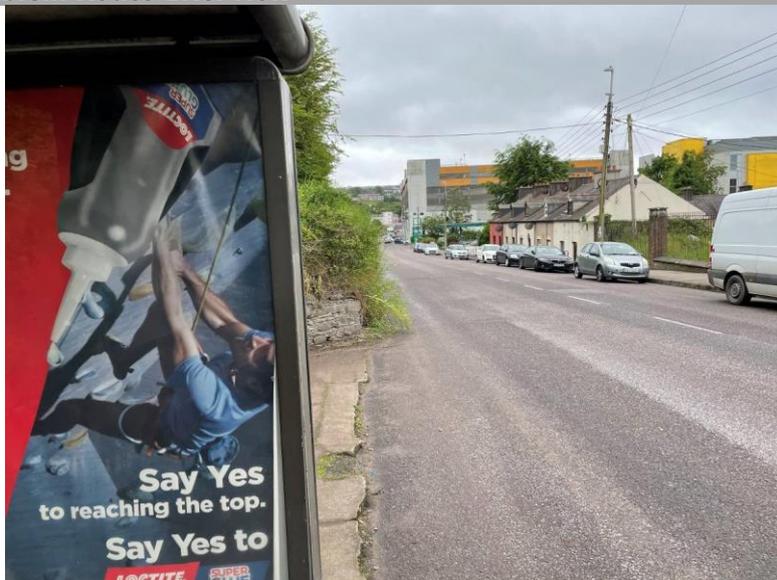
**6.1.7 QAR Problem Route 1 Ref No.7**

**Figure 6.7 Photo Direction F**

**Issue:** Forward visibility from the existing bus stop is blocked by nearby hedge overgrowth. The bus shelter offset should be setback to ensure visibility is not impeded.

**Recommendation:** Ensure appropriate forward visibility is provided to waiting commuters and pedestrians crossing the road at this location. Ensure kassel kerbing is employed at the new bus stop kerb edge.

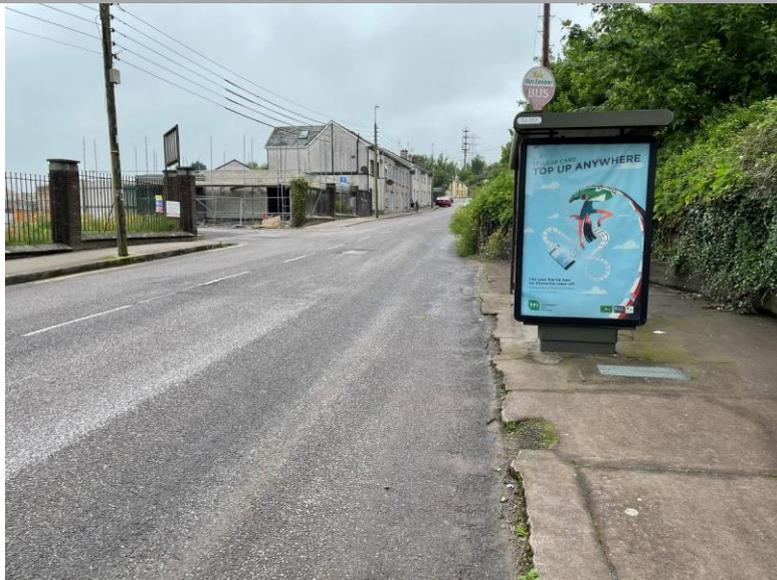
**6.1.8 QAR Problem Route 1 Ref No.8**

**Figure 6.8 Photo Direction G**

**Issue:** Forward visibility from the existing bus stop is blocked by nearby hedge overgrowth. The bus shelter offset should be setback to ensure visibility is not impeded.

**Recommendation:** Ensure appropriate forward visibility is provided to waiting commuters and pedestrians crossing the road at this location. Ensure kassel kerbing is employed at the new bus stop kerb edge.

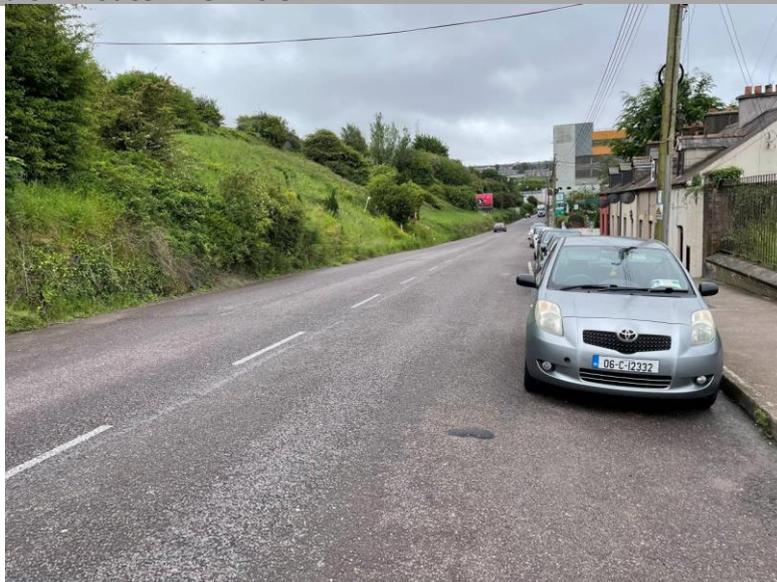
**6.1.9 QAR Problem Route 1 Ref No.9**

**Figure 6.9 Photo Direction G**

**Issue:** Forward visibility from the nearside footpath, opposite the far side existing bus stop is blocked by nearby street parking.

**Recommendation:** Ensure appropriate forward visibility is provided to waiting commuters and pedestrians crossing the road at this location. Ensure appropriate crossing facilities in the form of build outs and controlled crossing facilities are provided.

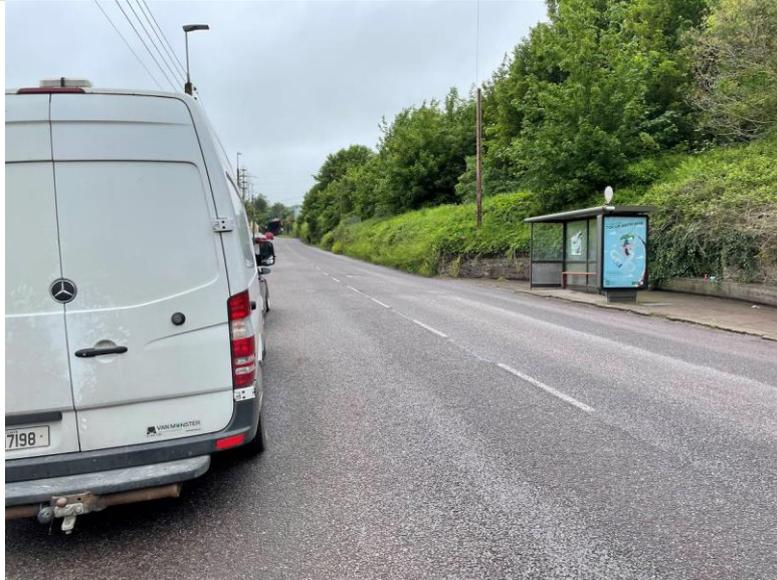
**6.1.10 QAR Problem Route 1Ref No.10**

**Figure 6.10 Photo Direction H**

**Issue:** Forward visibility from the nearside footpath, opposite the far side existing bus stop is blocked by nearby street parking.

**Recommendation:** Ensure appropriate forward visibility is provided to waiting commuters and pedestrians crossing the road at this location. Ensure appropriate crossing facilities in the form of build outs and controlled crossing facilities are provided.

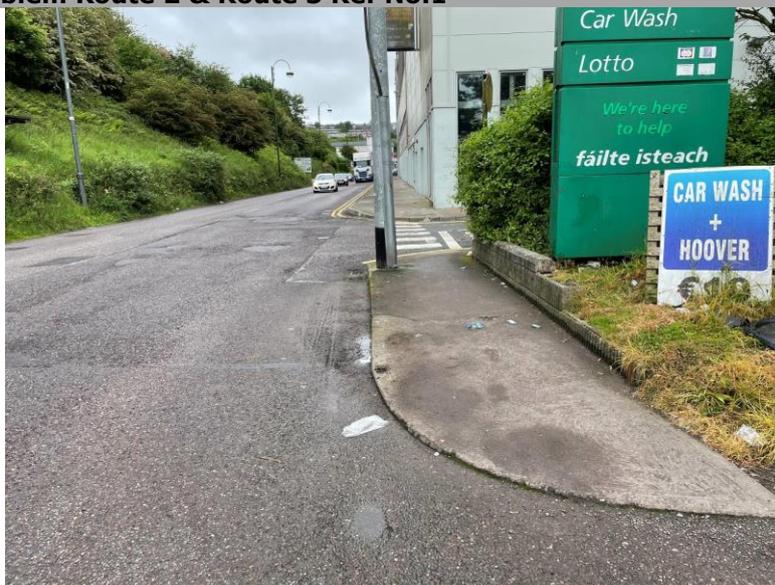
### 7.1.1 QAR Problem Route 2 & Route 3 Ref No.1

**Figure 7.1 Photo Direction I**

**Issue:** The wide entrance between the applicant's site boundary and nearby retail park, is a discontinuity in the pedestrian facilities at this location. The pedestrian priority is not evident with no appropriate signage present. The footpath is at grade with the nearby carriageway, such that vulnerable road users are at higher risk from collision potentially due to the lack of vehicle separation.

**Recommendation:** Provide appropriate signage, uncontrolled tactile paving/dropped kerbing and pedestrian crossing facilities at this location to ensure continuity of the footpath network.

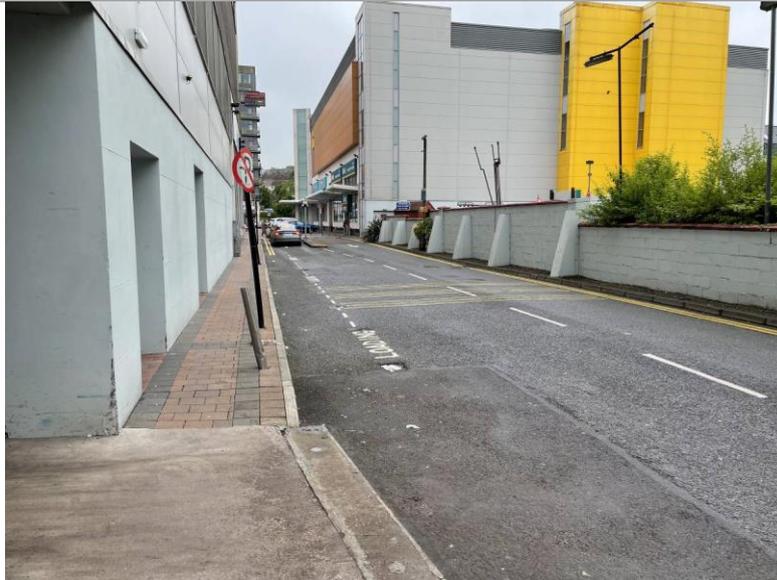
7.1.2 QAR Problem Route 2 & Route 3 Ref No.2

Figure 7.2 Photo Direction R

**Issue:** The existing pedestrian footpath facilities along the Retail Park Laneway are poor, with a very narrow footpath available on one side of the lane. The existing laneway is a single carriageway with entry/exit traffic from the nearby retail area. Vulnerable road users are at higher risk from collision potentially due to the lack of vehicle separation.

**Recommendation:** Provide appropriate footpath widths to facilitate the passing footfall along this section of roadway, insuring nearby loading areas are prevented from blocking pedestrian along this desire line, which could lead to pedestrians being forced to enter the vehicle trafficked area.

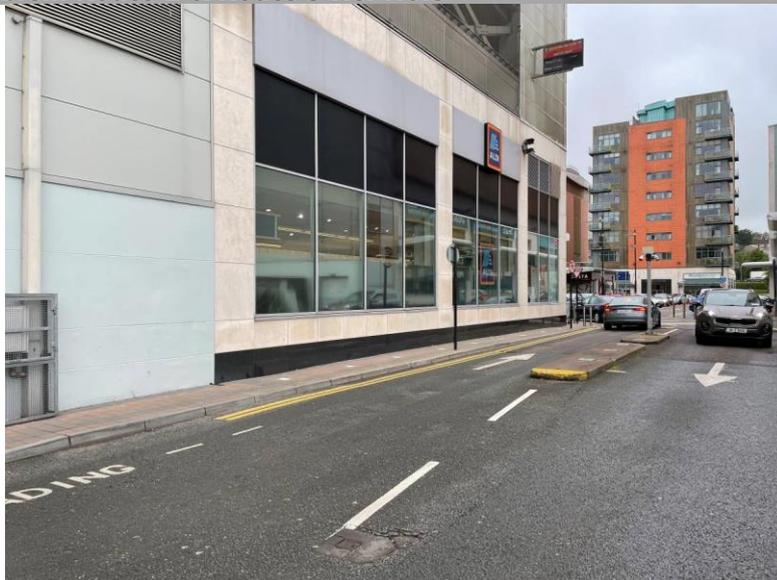
7.1.3 QAR Problem Route 2 & Route 3 Ref No.3

Figure 7.3 Photo Direction S

**Issue:** Narrow footpaths on the Retail Park laneway may present difficulties for vulnerable road users.

**Recommendation:** The footpath on the applicant side should be designed to an appropriate standard to safely accommodate pedestrians along this route.

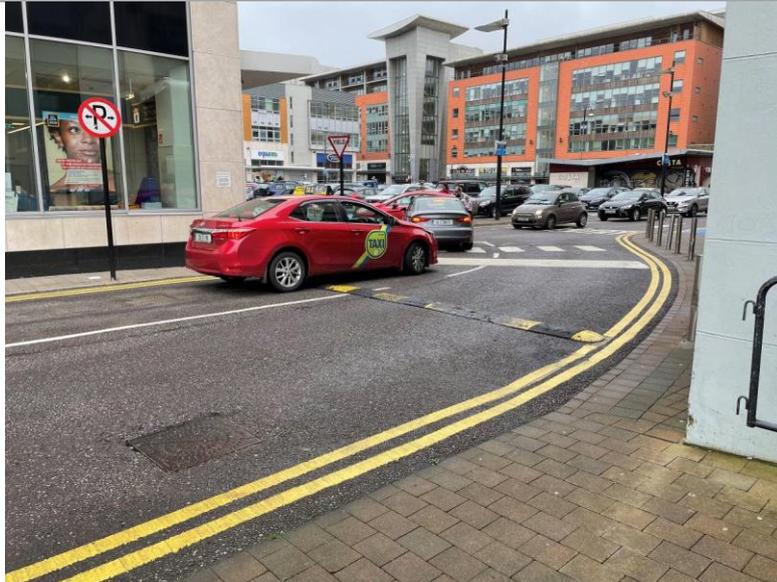
7.1.4 QAR Problem Route 2 & Route 3 Ref No.5

Figure 7.4 Photo Direction U

**Issue:** Pedestrian footpath widths to the retail park from the applicant’s back site access are restricted. Unregulated pedestrian crossings could lead to collision, injury with passing traffic.

**Recommendation:** This is outside the control of the applicant and that the retail park should improve connectivity at the location.

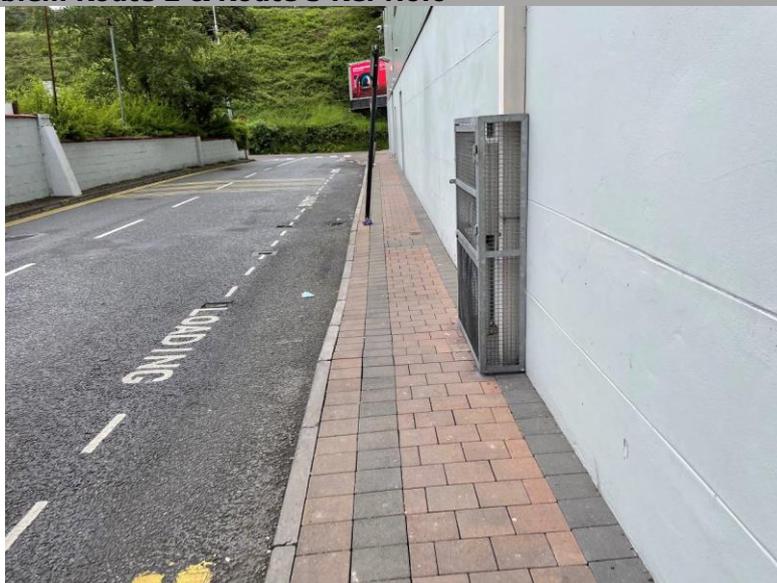
7.1.5 QAR Problem Route 2 & Route 3 Ref No.6

Figure 7.5 Photo Direction V

**Issue:** Narrow footpaths on the Retail Park laneway may present difficulties for vulnerable road users.

**Recommendation:** This is outside the control of the applicant and that the retail park should improve connectivity at the location. The footpath on the applicant side should be designed to an appropriate standard to safely accommodate pedestrians along this route. Ensure appropriate footpaths width are developed to provide adequate mobility and protection for vulnerable road users to the nearby retail park.

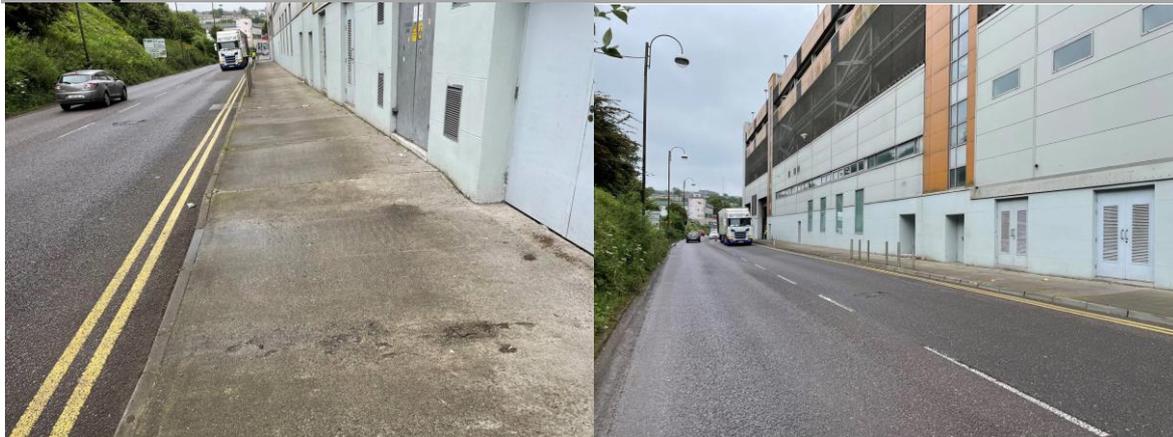
### 8.1.1 QAR Problem Route 4 Ref No.1

**Figure 8.1 Photo Direction J , K**

**Issue:** The existing wide carriageway of Redforge Road is a vehicle dominated design, with the nearby multi storey carpark imposing on the roadway. This section of roadway is a pleasant streetscape, with vulnerable road users exposed to passing traffic.

**Recommendation:** Provide streetscape improvement measures compliant to DMURs standards to ensure this link is a pedestrian friendly one, enhancing the desire line for existing and future residents/ pedestrian of the area.

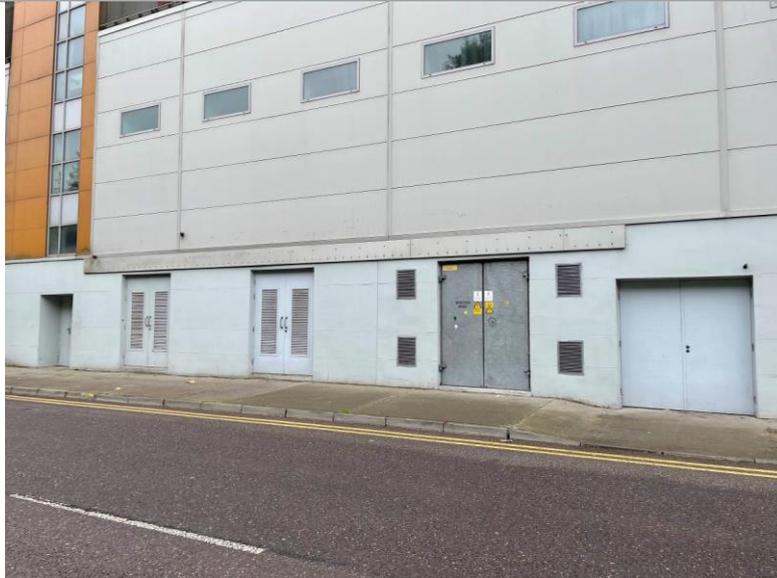
### 8.1.2 QAR Problem Route 4 Ref No.2

**Figure 8.2 Photo Direction L**

**Issue:** The rear of the retail park has numerous access ways along this section of the desire line. These should be accommodated in any street improvement works to ensure pedestrian safety as well as providing access for maintenance of the retail park.

**Recommendation:** Provide streetscape improvement measures compliant to DMURs standards to ensure this link is a pedestrian friendly one, ensuring the Blackpool Retail Park access is maintained.

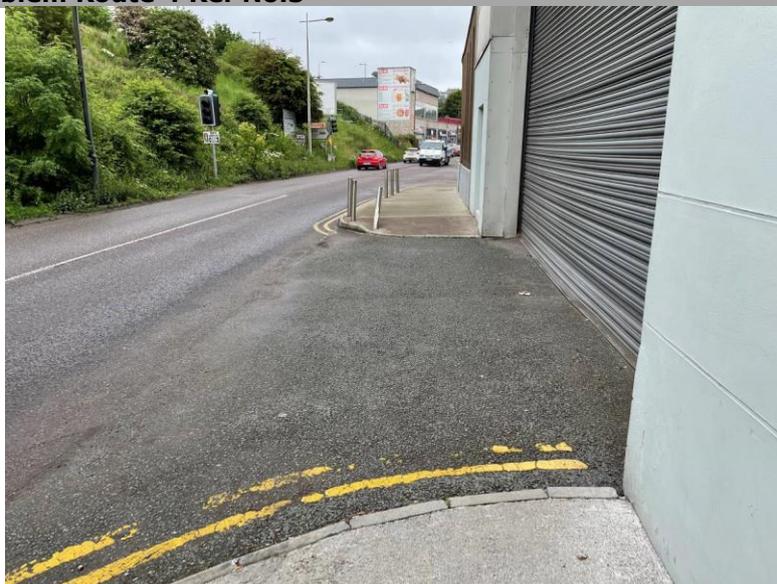
### 8.1.3 QAR Problem Route 4 Ref No.3

**Figure 8.3 Photo Direction M**

**Issue:** The wide access entrances to the back of nearby retail park are hazards, presenting a discontinuity in the pedestrian facilities at these locations. The pedestrian priority is not evident with no appropriate signage present. The footpath is at grade with the nearby carriageway, such that vulnerable road users are at higher risk from collision potentially due to the lack of vehicle separation.

**Recommendation:** Provide appropriate signage, uncontrolled tactile paving/dropped kerbing and pedestrian crossing facilities at this location to ensure continuity of the footpath network.

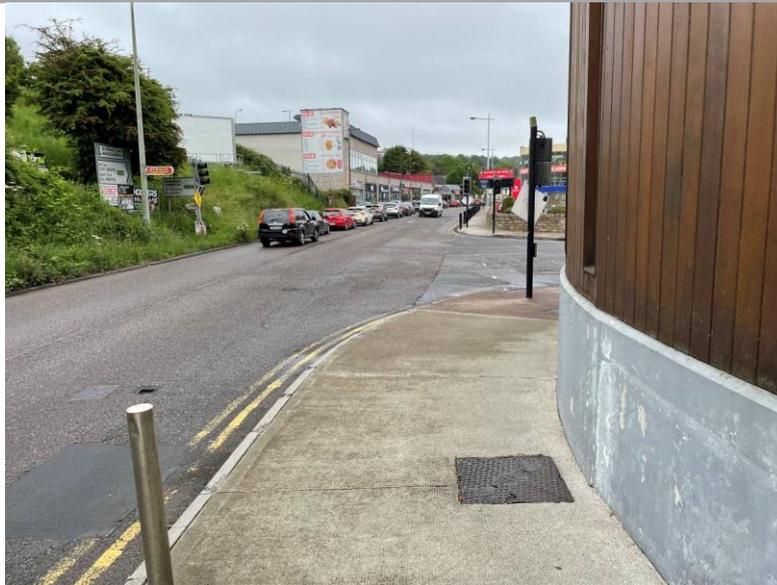
#### 8.1.4 QAR Problem Route 4 Ref No.4

**Figure 8.4 Photo Direction N**

**Issue:** The pedestrian protection at this crossing location is poor. At the crossing, the existing traffic junction's poles narrow the available footpath space available for passing footpath and pedestrian waiting to cross the road at this location.

**Recommendation:** The poor footpath surface should be replaced at this location, with appropriate signalised red tactile paving installed. The exiting poles should be repositioned to provide appropriate pedestrian footpath widths.

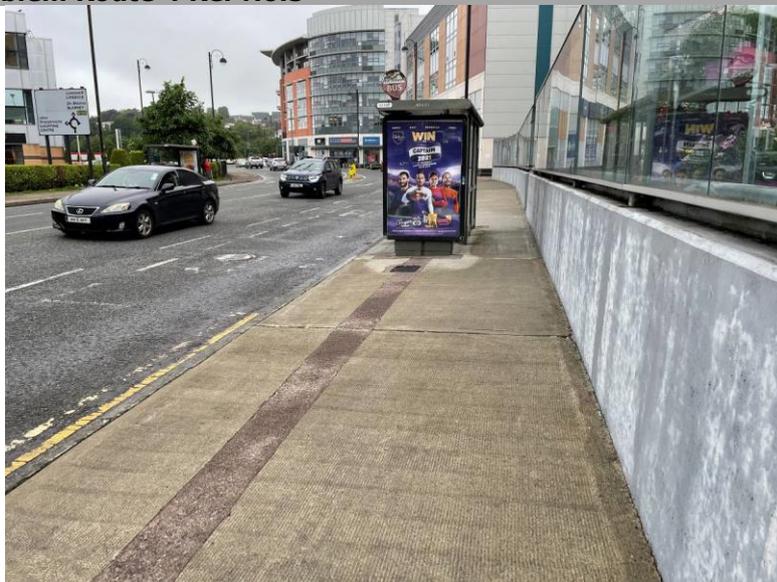
#### 8.1.5 QAR Problem Route 4 Ref No.5

**Figure 8.5 Photo Direction O**

**Issue:** The existing footpath has deteriorated in certain locations, which the existing bus stop shelter confining the available footpath widths for passing pedestrians. These confined dimensions can lead to mobility issues for wheelchair access and lead to pedestrian / vulnerable road users entering into the road carriageway at this location, leading to potential collisions.

**Recommendation:** Poor footpath surface should be replaced. The bus shelter positioning should reflect the passing of pedestrian traffic / wheelchair and child buggy footfall.

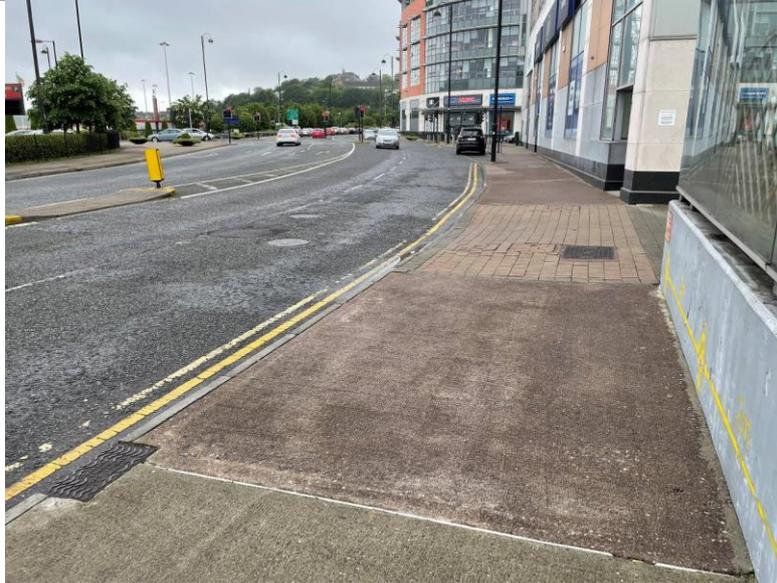
**8.1.6 QAR Problem Route 4 Ref No.6**

**Figure 8.6 Photo Direction P**

**Issue:** The existing footpath at the drop kerb location as shown has no pedestrian protection/ vehicle restraint to protect vulnerable road users at this location. Protection measures in the form of bollards, planters, etc should be provided.

**Recommendation:** Provide appropriate pedestrian protection at this location.

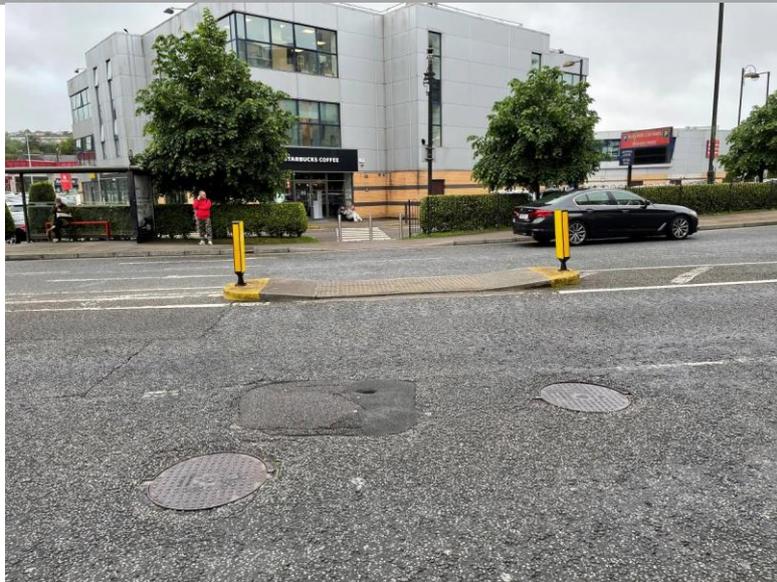
**8.1.7 QAR Problem Route 4 Ref No.7**

**Figure 8.7 Photo Direction Q**

**Issue:** The existing uncontrolled crossing location is poorly defined, with sub optimal pedestrian protection/ vehicle restraint provided.

**Recommendation:** Provide appropriate pedestrian crossing facilities at this this location.
