Proposed Mixed Use Development

Quality Audit Report

**SEPTEMBER 2021**

<b>Client</b>	Bellmount Developments
<b>Project Title</b>	Proposed Mixed Use Development
<b>Project Location</b>	Blackpool, Cork City
<b>Document Title</b>	Quality Audit Report
<b>Document No.</b>	MHL-20068TT-RED-DOC04-QAR
<b>Job No.</b>	20068TT

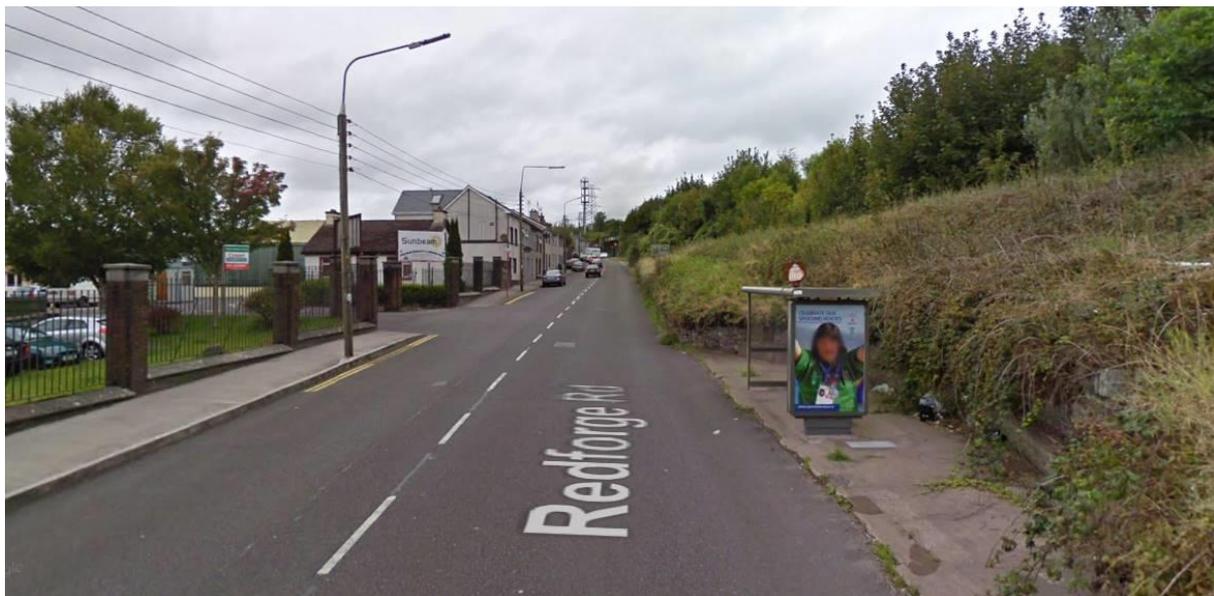
**Figure 3.4 Bus Stop north of site boundary**

An existing footpath is provided on the near side of the Redforge Road. Although the Redforge Road is utilitarian in its current form, the connectivity beyond the immediate vicinity of Redforge road is considered suitable for purpose, especially factoring in the revised urban street layouts proposals developed for this application. On the morning of the site visit pedestrian numbers were limited, however the Covid-19 restrictions may have impacted on the pedestrian activity. There are bus shelters on both sides of the Redforge Road near the proposed development access. The city (inbound) service bus stop is immediately north to the site boundary. Cyclists share the carriageway on the Redforge Road.
